# Exterior Facilities Study Report

Regional School District 8

RHAM High School and RHAM Middle School

December 30, 2015

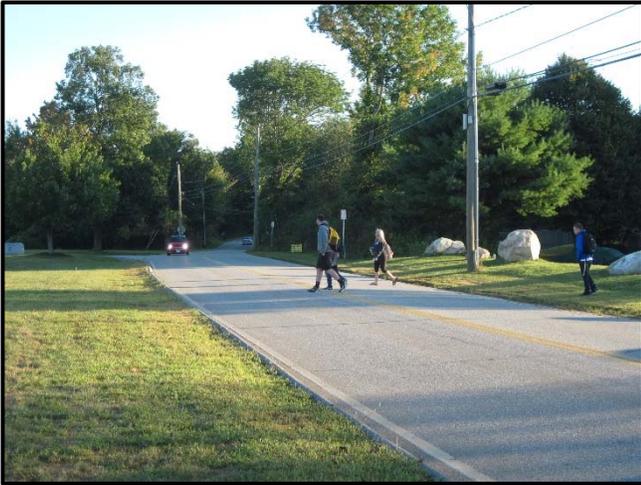
Photo 1 – Students crossing Wall Street

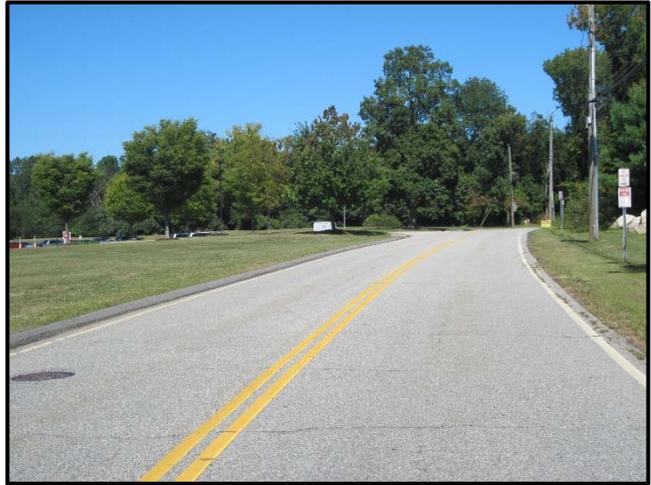
Photo 2 – Obscured Main Entrance

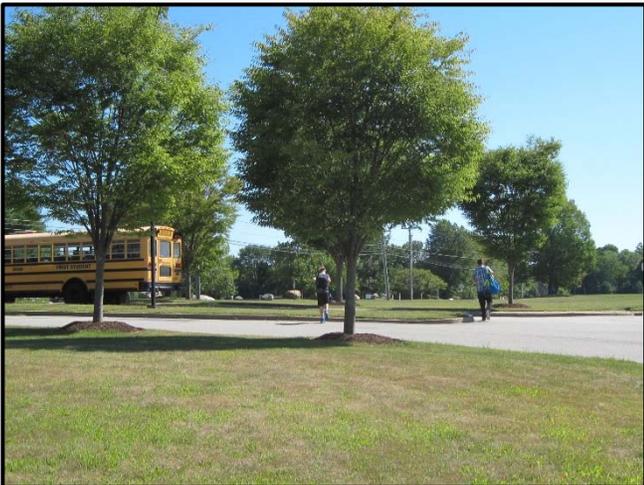
Photo 3 – Poor Sight Lines at Crosswalk

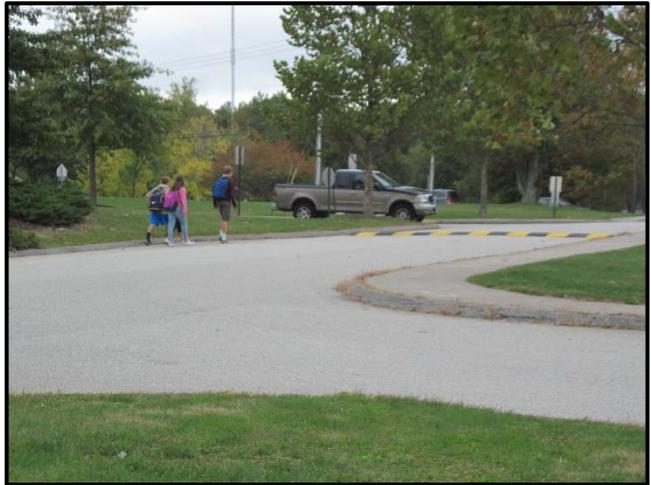
Photo 4 – Poor Sight Lines at Crosswalk

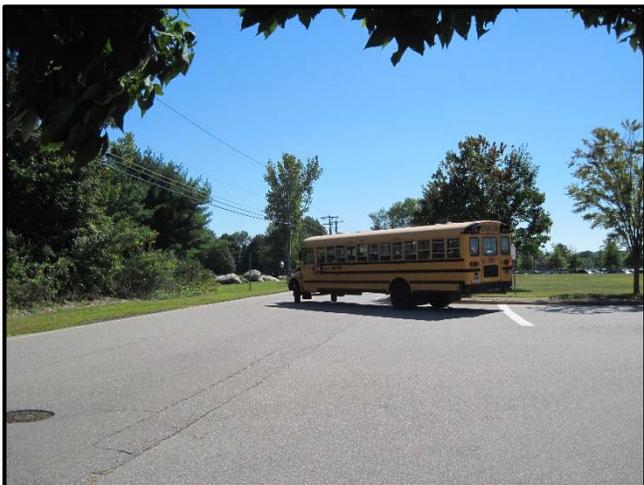
Photo 5 – Main Entrance – Poor Radius for Bus

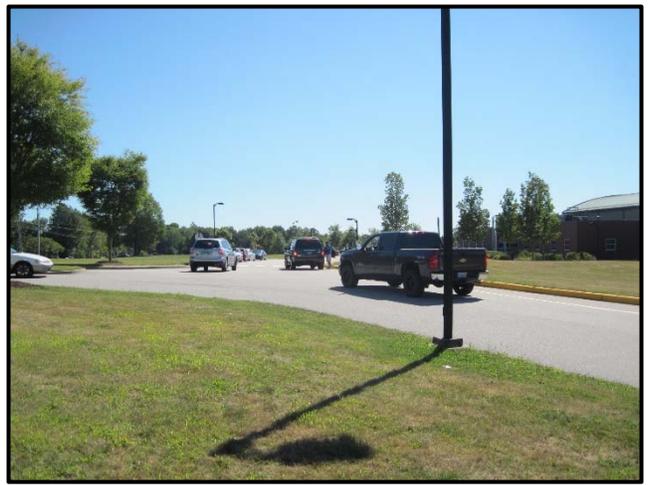
Photo 6 – Main Entrance - Lack of Intersection Control

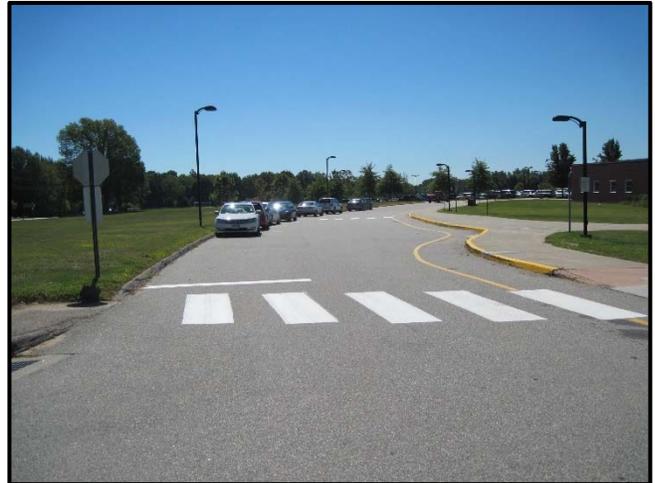
Photo 8 – High School Drop Off Loop Poor Layout of Parking vs. Stop Bar

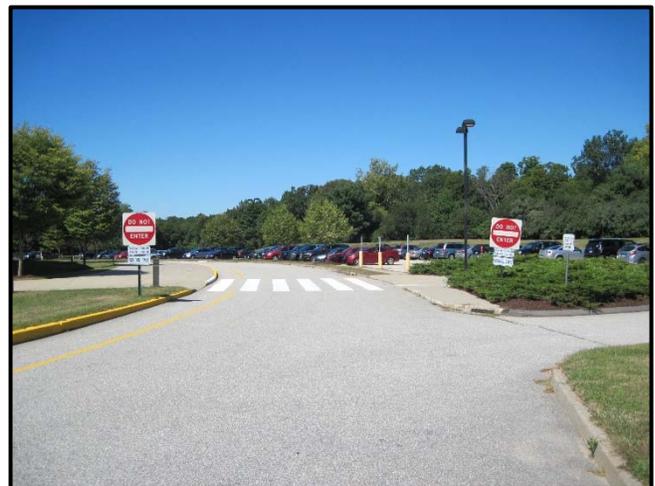
Photo 10 – Excessive Sign Information

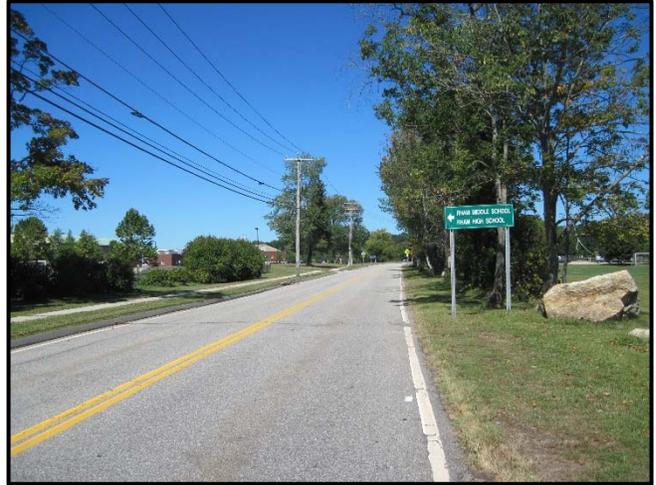
Photos 12 and 13 – Signs on Wall Street Direct Traffic to School Secondary Entrance

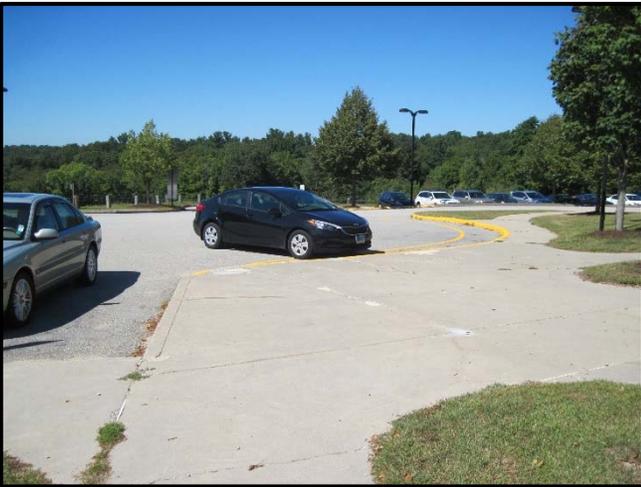
Photo 14 – Poor Delineation of Parking

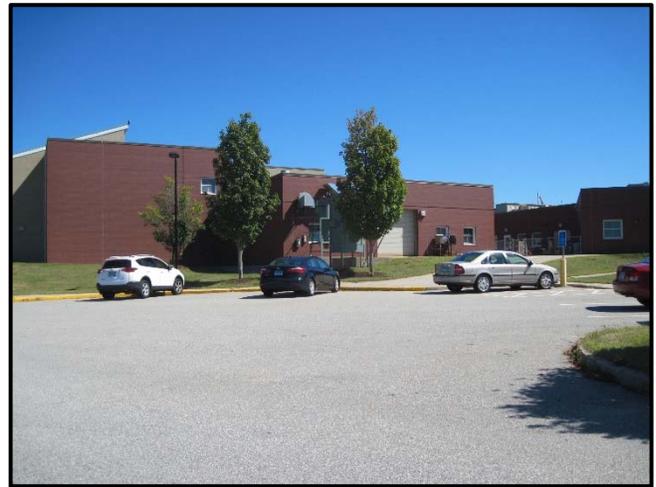
Photo 15 – Poor Delineation of Parking

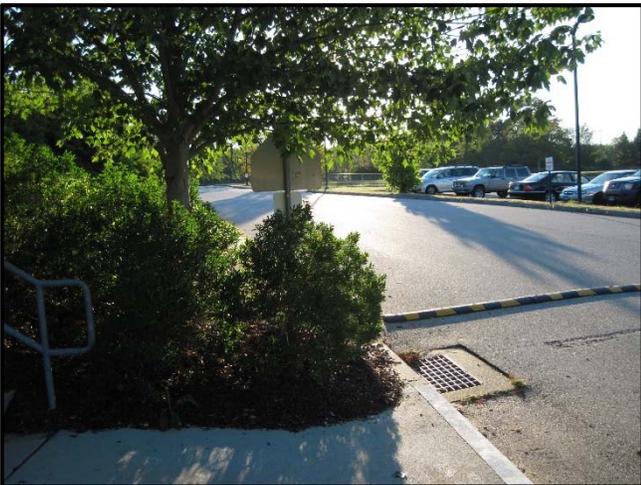
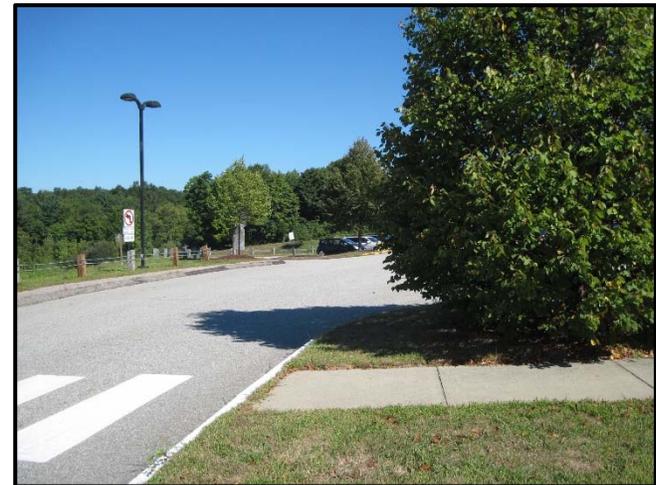
Photos 16 and 17 – Poor Sight Lines Crosswalks

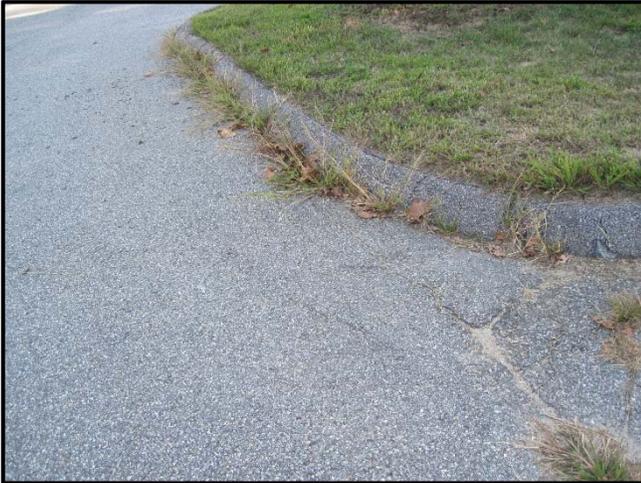
Photo 1 - Example of Debris Along Curb

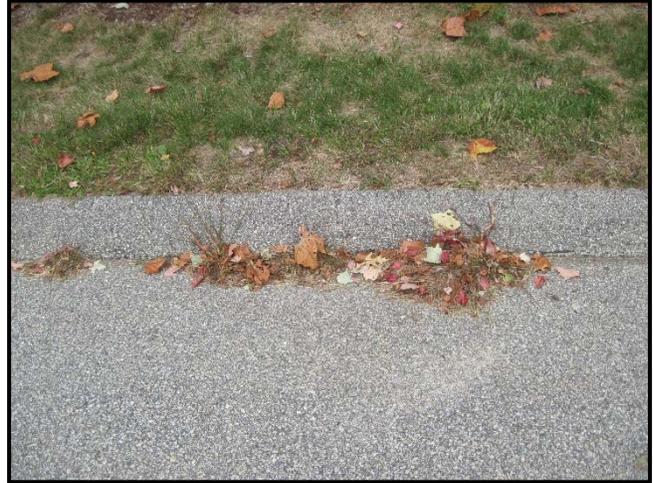
Photo 2 - Example of Debris Along Curb

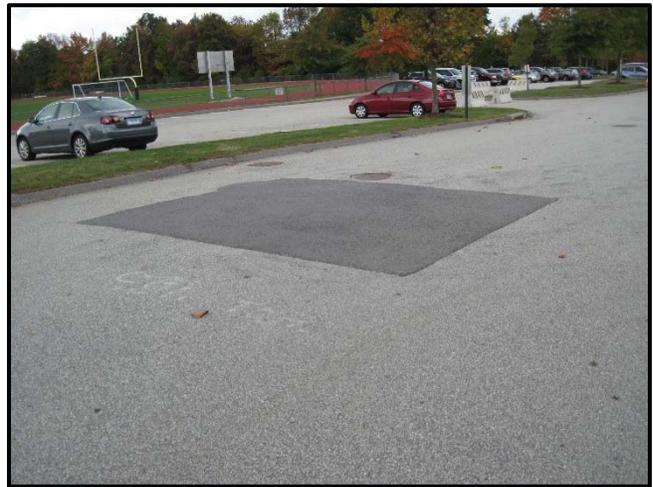
Photo 4 - Example of Patching

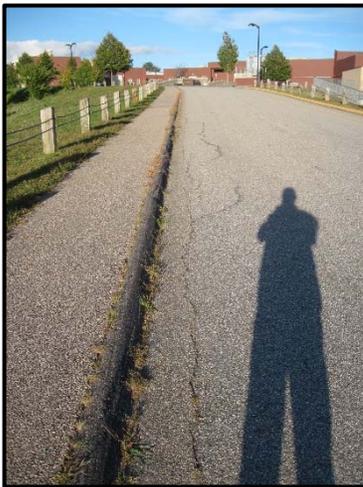
Photo 5 - Example of Edge Cracking

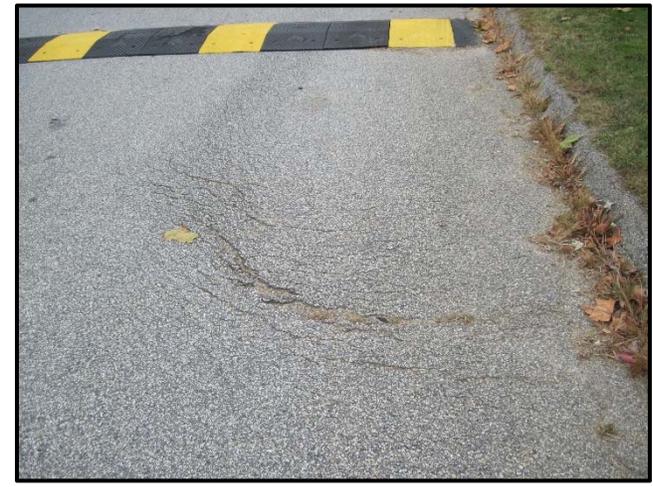
Photo 6 - Example of Slippage Cracking

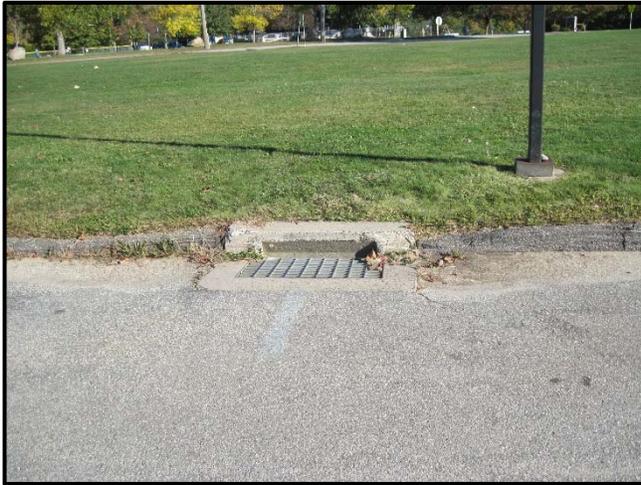
Photo 7 - Example of Debris Along Curb

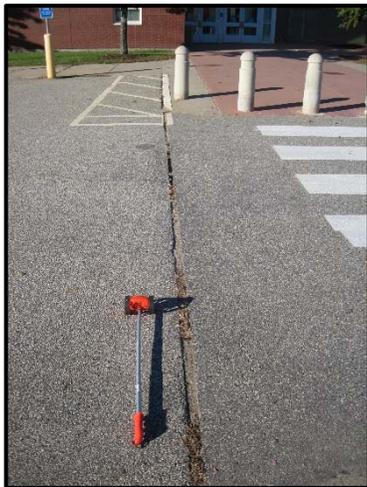
Photo 9 - Example Transverse Cracking

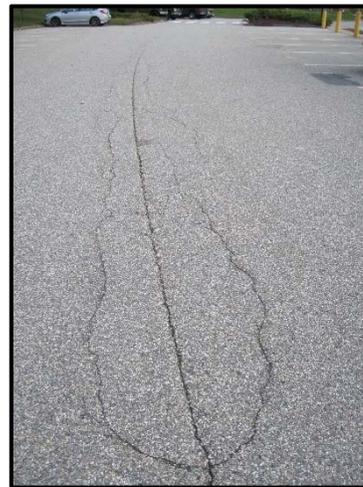
Photo 10 - Example of Longitudinal Cracking

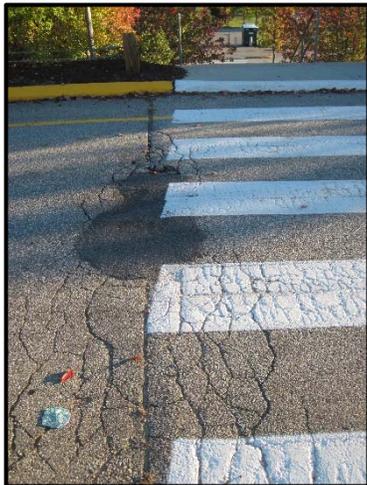
Photo 11 - Example of Alligator Cracking

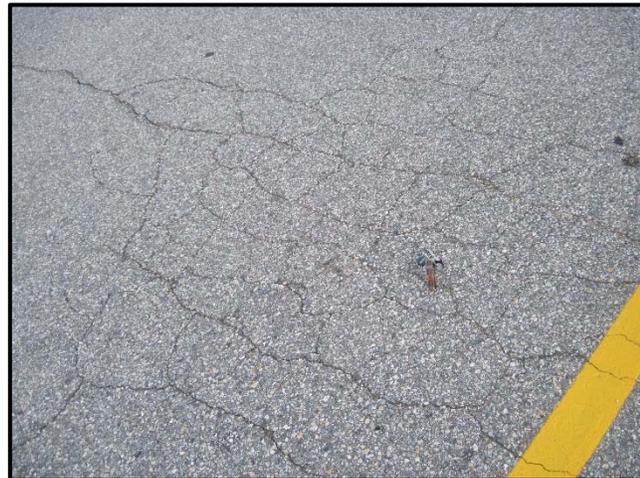
Photo 12 - Example of Block Cracking

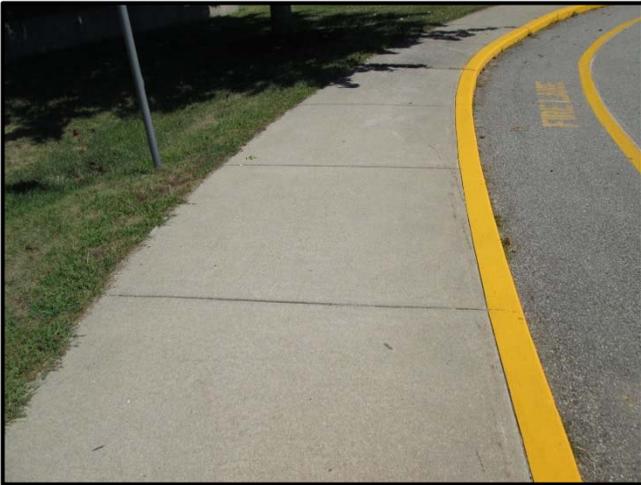
Photo 1 – Panel with Grade of “Acceptable”

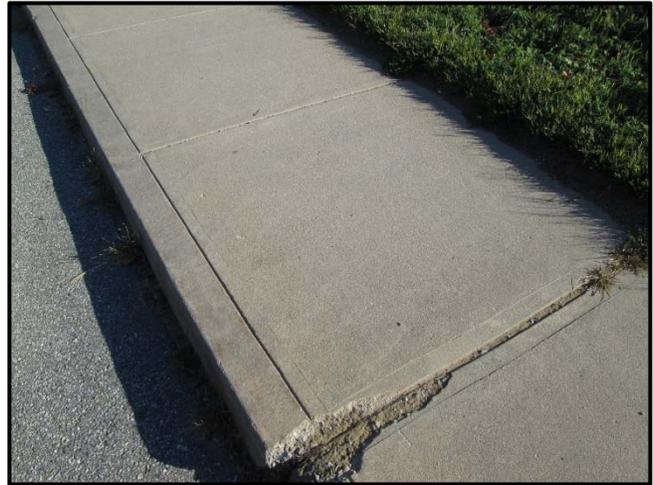
Photo 2 – Panel with Grade of “Repair Required”

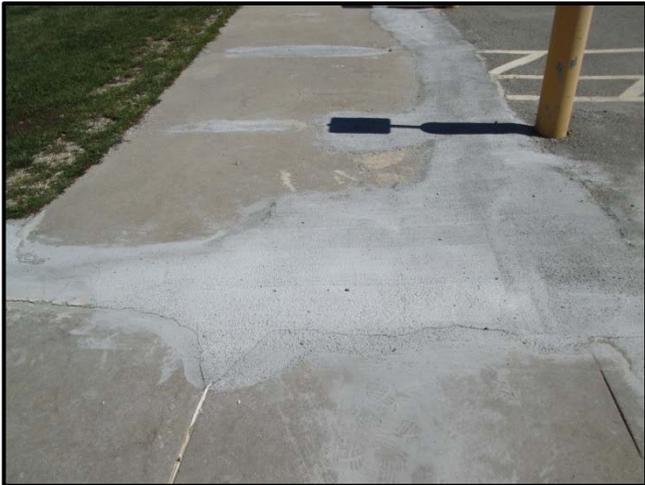
Photo 3 – Panel with Grade of “Replacement Required”

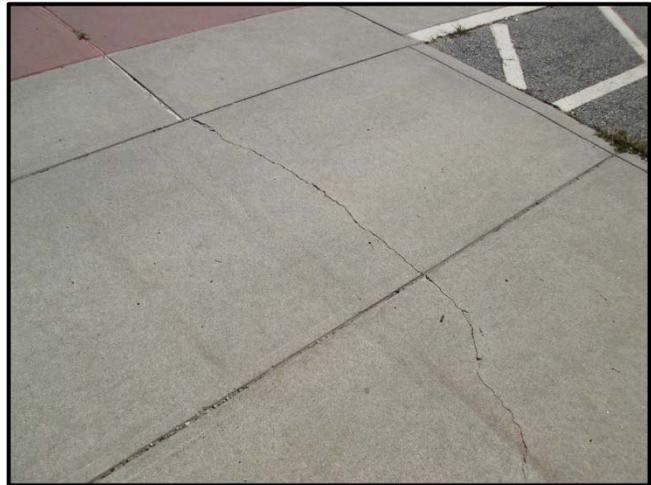
Photo 4 – Typical Panel with “Repairable” Crack

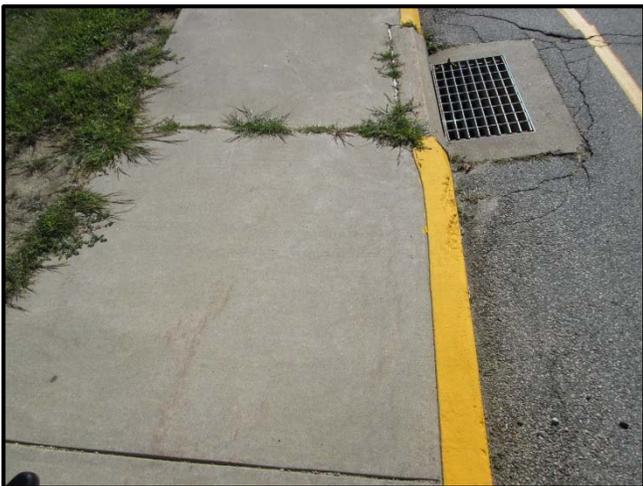
Photo 5 – Typical Vegetation in Joint

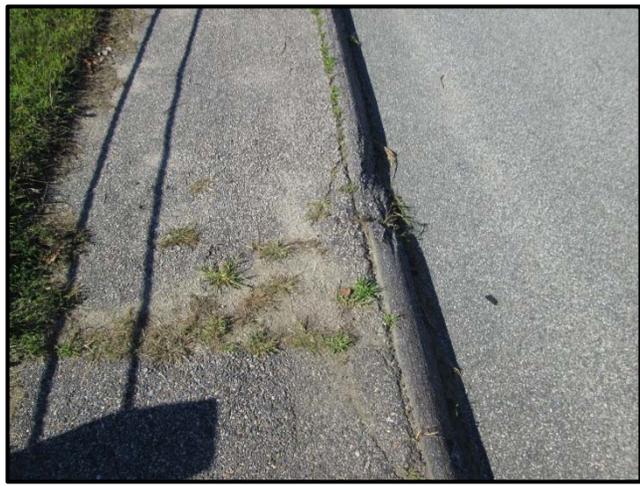
Photo 6 – Typical Bituminous Replacement Area

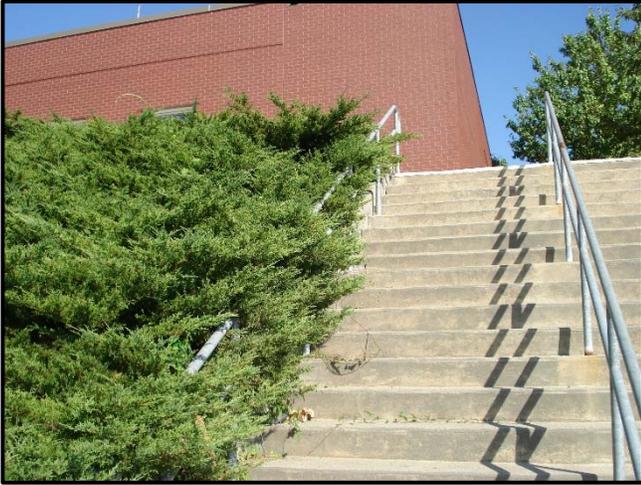
Photo 1 – Vegetation encroaching on stairs

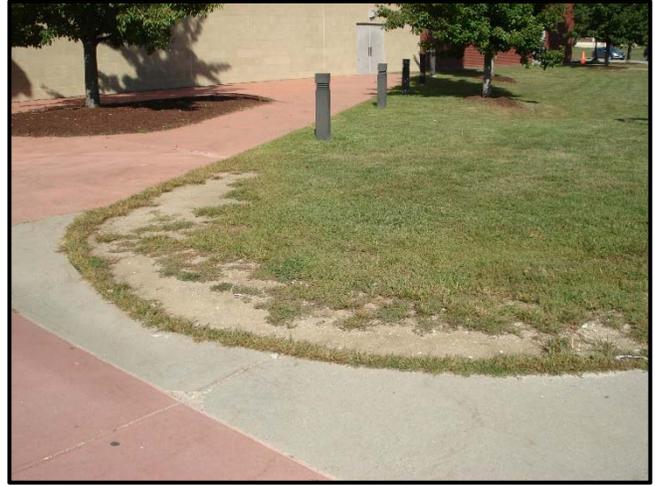
Photo 2 – Typical poor lawn area

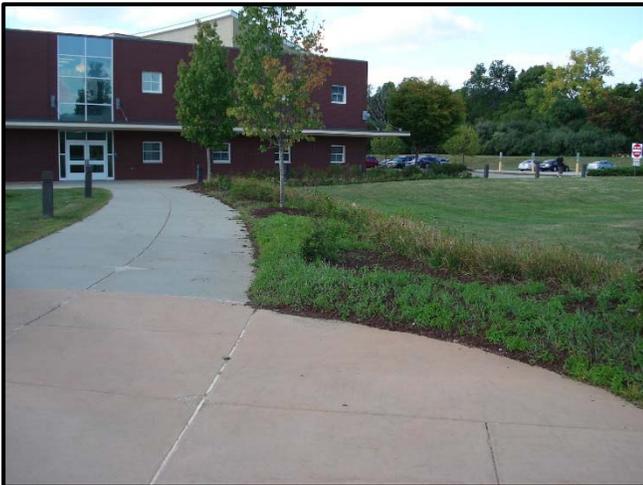
Photo 3 – Inconsistent shrub plantings

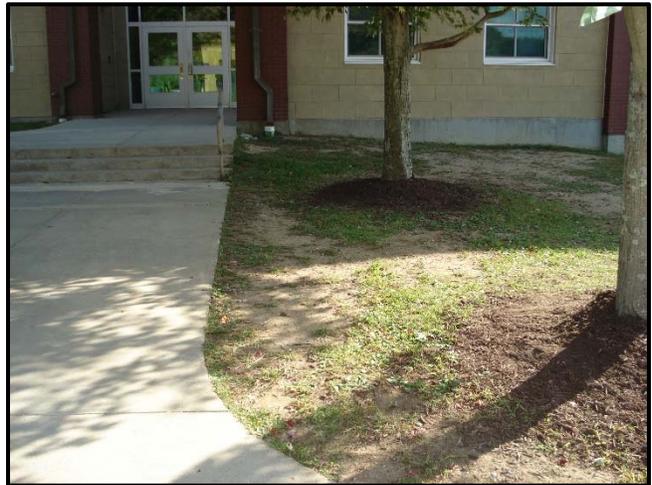
Photo 4 – Poor lawn area under trees

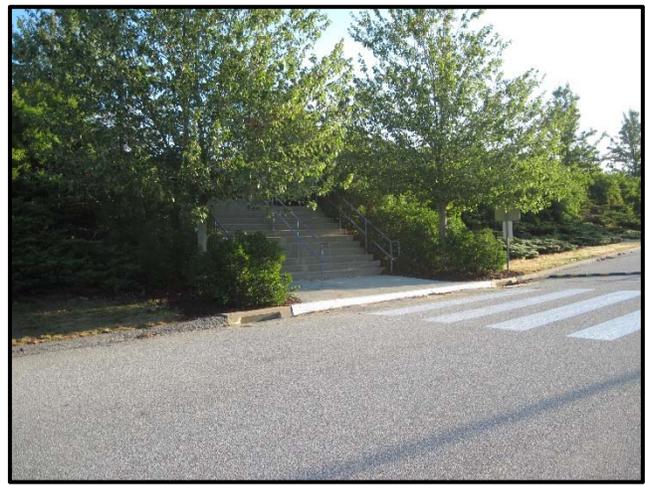
Photo 6 – Reduced visibility at crosswalk

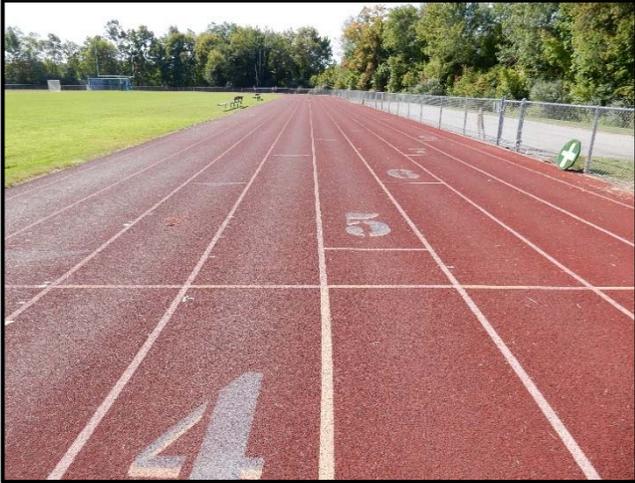
Photo 1 – Typical worn track surfacing

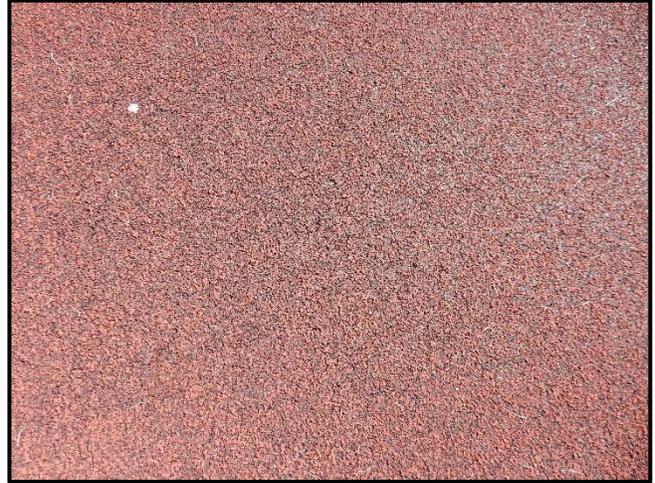
Photo 2 – Close-up of track surfacing

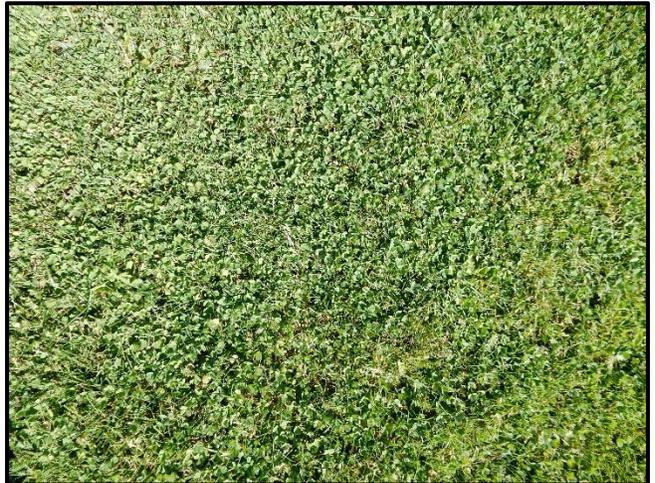
Photo 4 – Close-up of grass condition

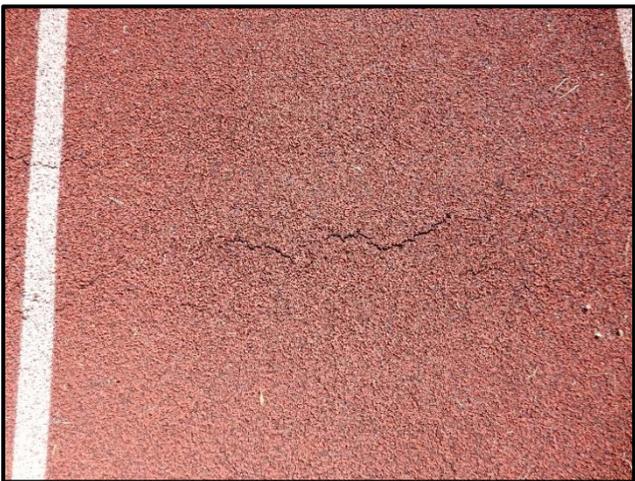
Photo 5 – Typical cracking in track surfacing

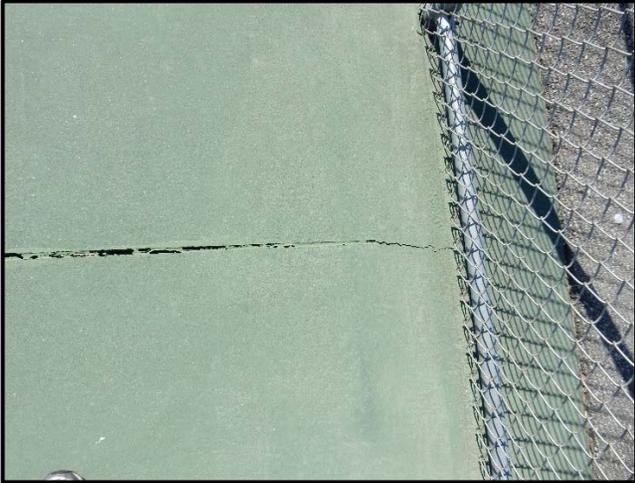
Photo 1 – Typical cracking at perimeter fence

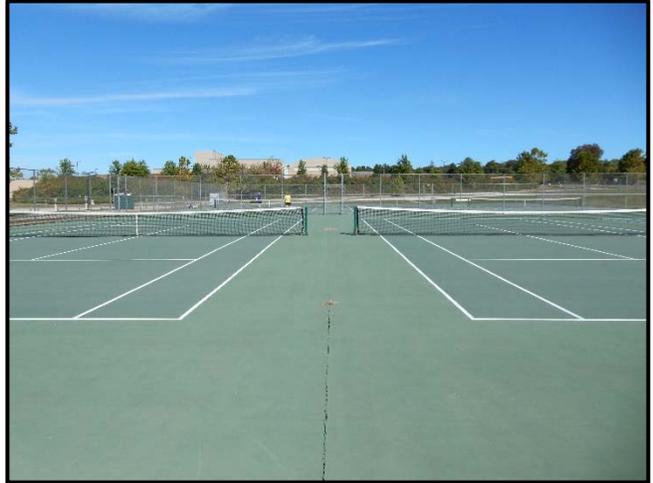
Photo 2 – Typical cracking between courts

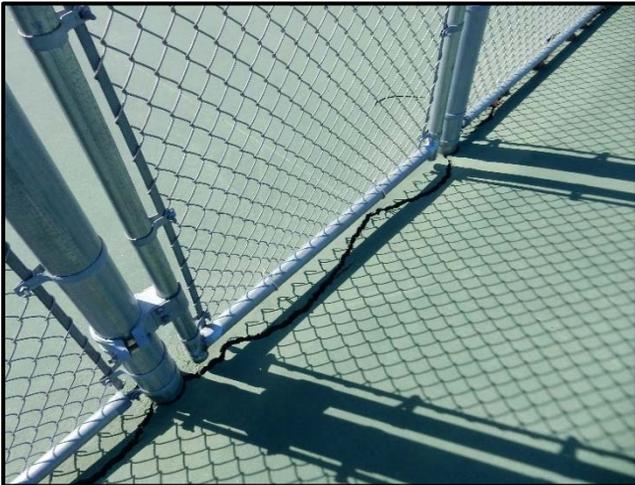
Photo 3 – Typical cracking between court batteries

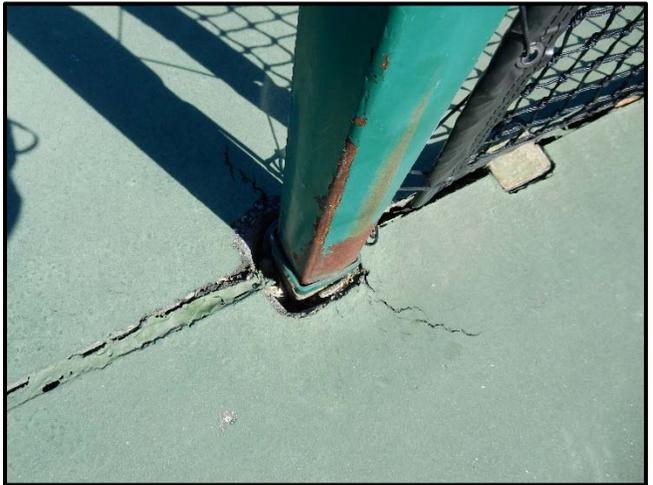
Photo 4 – Court condition around net post

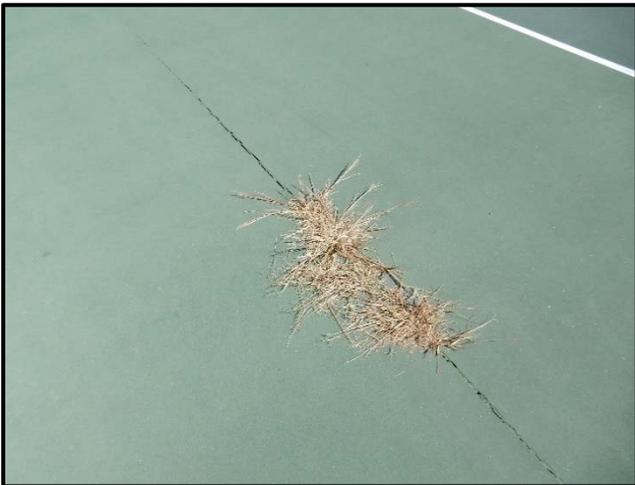
Photo 5 – Typical cracking

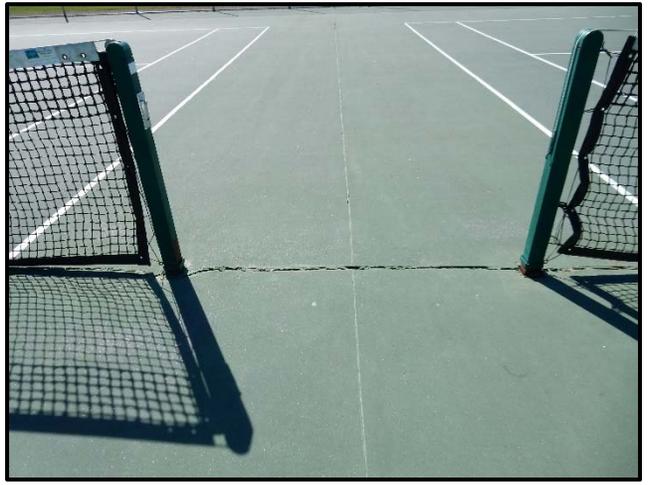
Photo 6 – Cracking between net posts

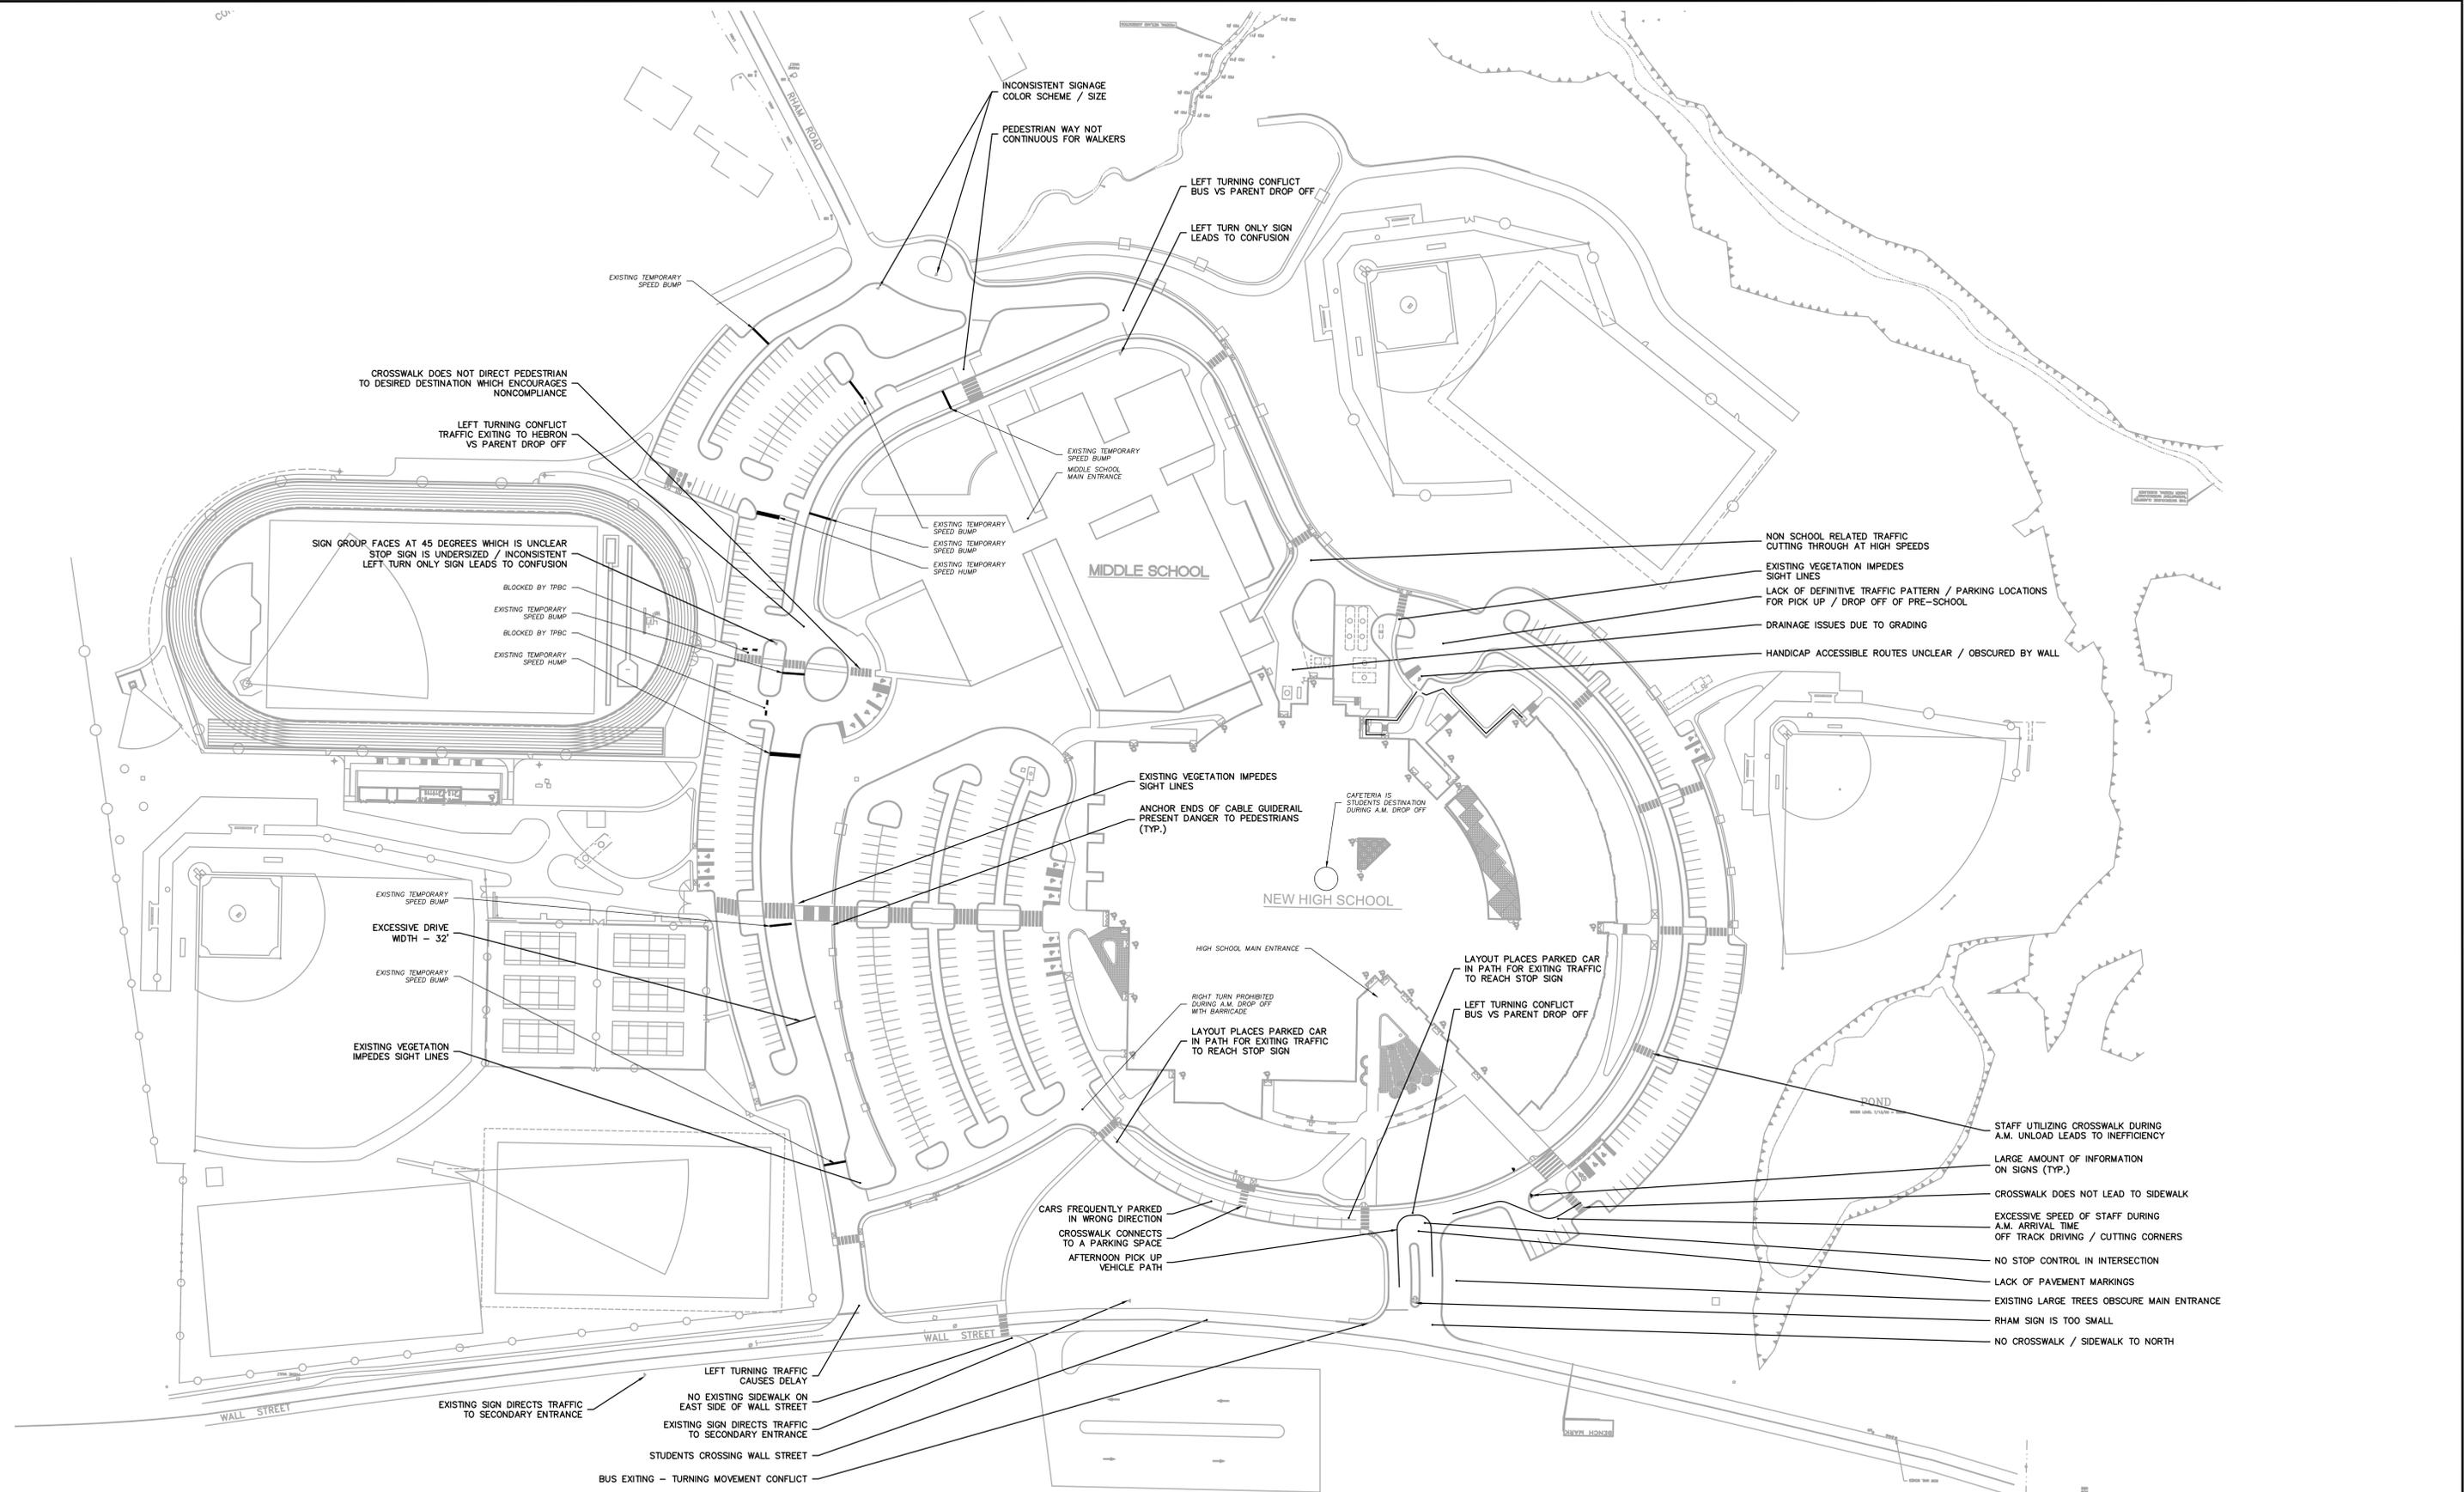
**Figure 3- Issue Identification Plan  
RHAM High School Exterior Site Improvements**

As previously noted in Section 2, BSC has identified and summarized the campus traffic issues in graphical format on Figure 3 "Traffic Circulation Existing Conditions Assessment Plan". The most significant issues identified are listed below, however this list is not intended to be comprehensive. Please refer to Figure 3 for additional information on campus issues, as well as the short term (Figure 4) and long term (Figure 5) figures for associated recommended improvements.

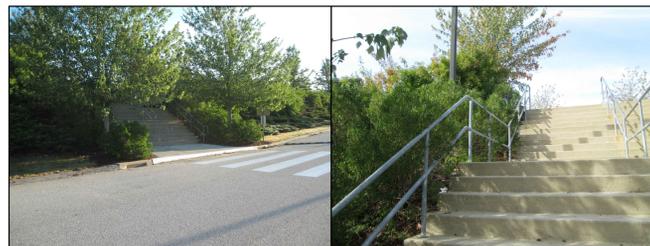
- SHRUBS AND LOW BRANCHING TREES REDUCE VISIBILITY OF PEDESTRIANS AT CROSSWALK.
- SHRUBS ENCROACHING ON STAIR.
- SHRUB PROHIBITING ABILITY TO GRAB HAND RAIL.

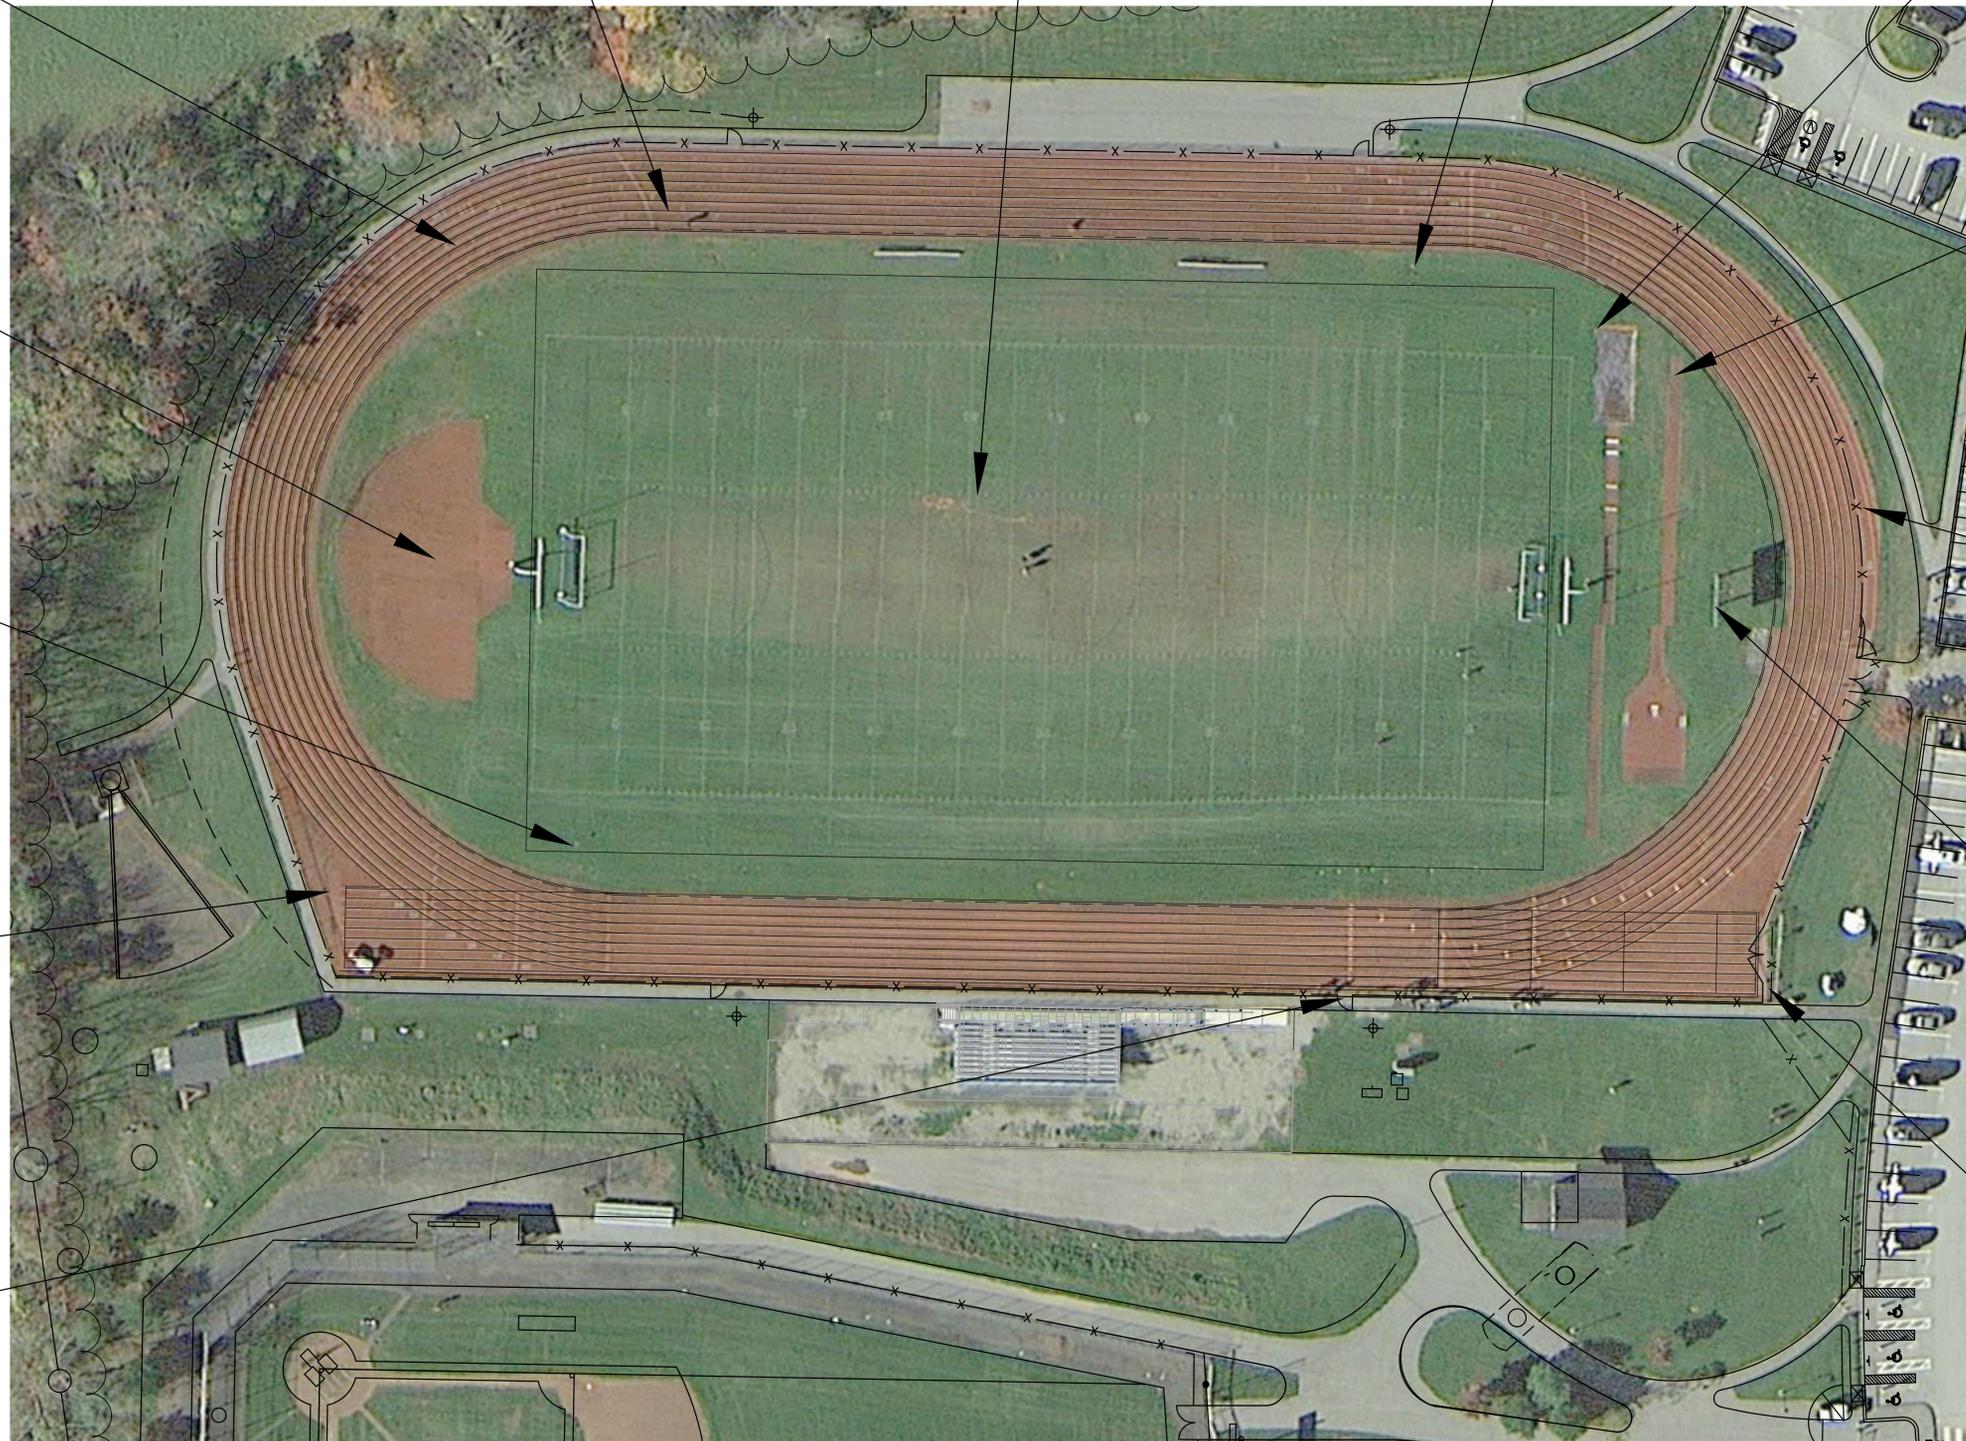
- TRACK SURFACING REPAIR/REMOVAL.
- DETERIORATING EDGE.

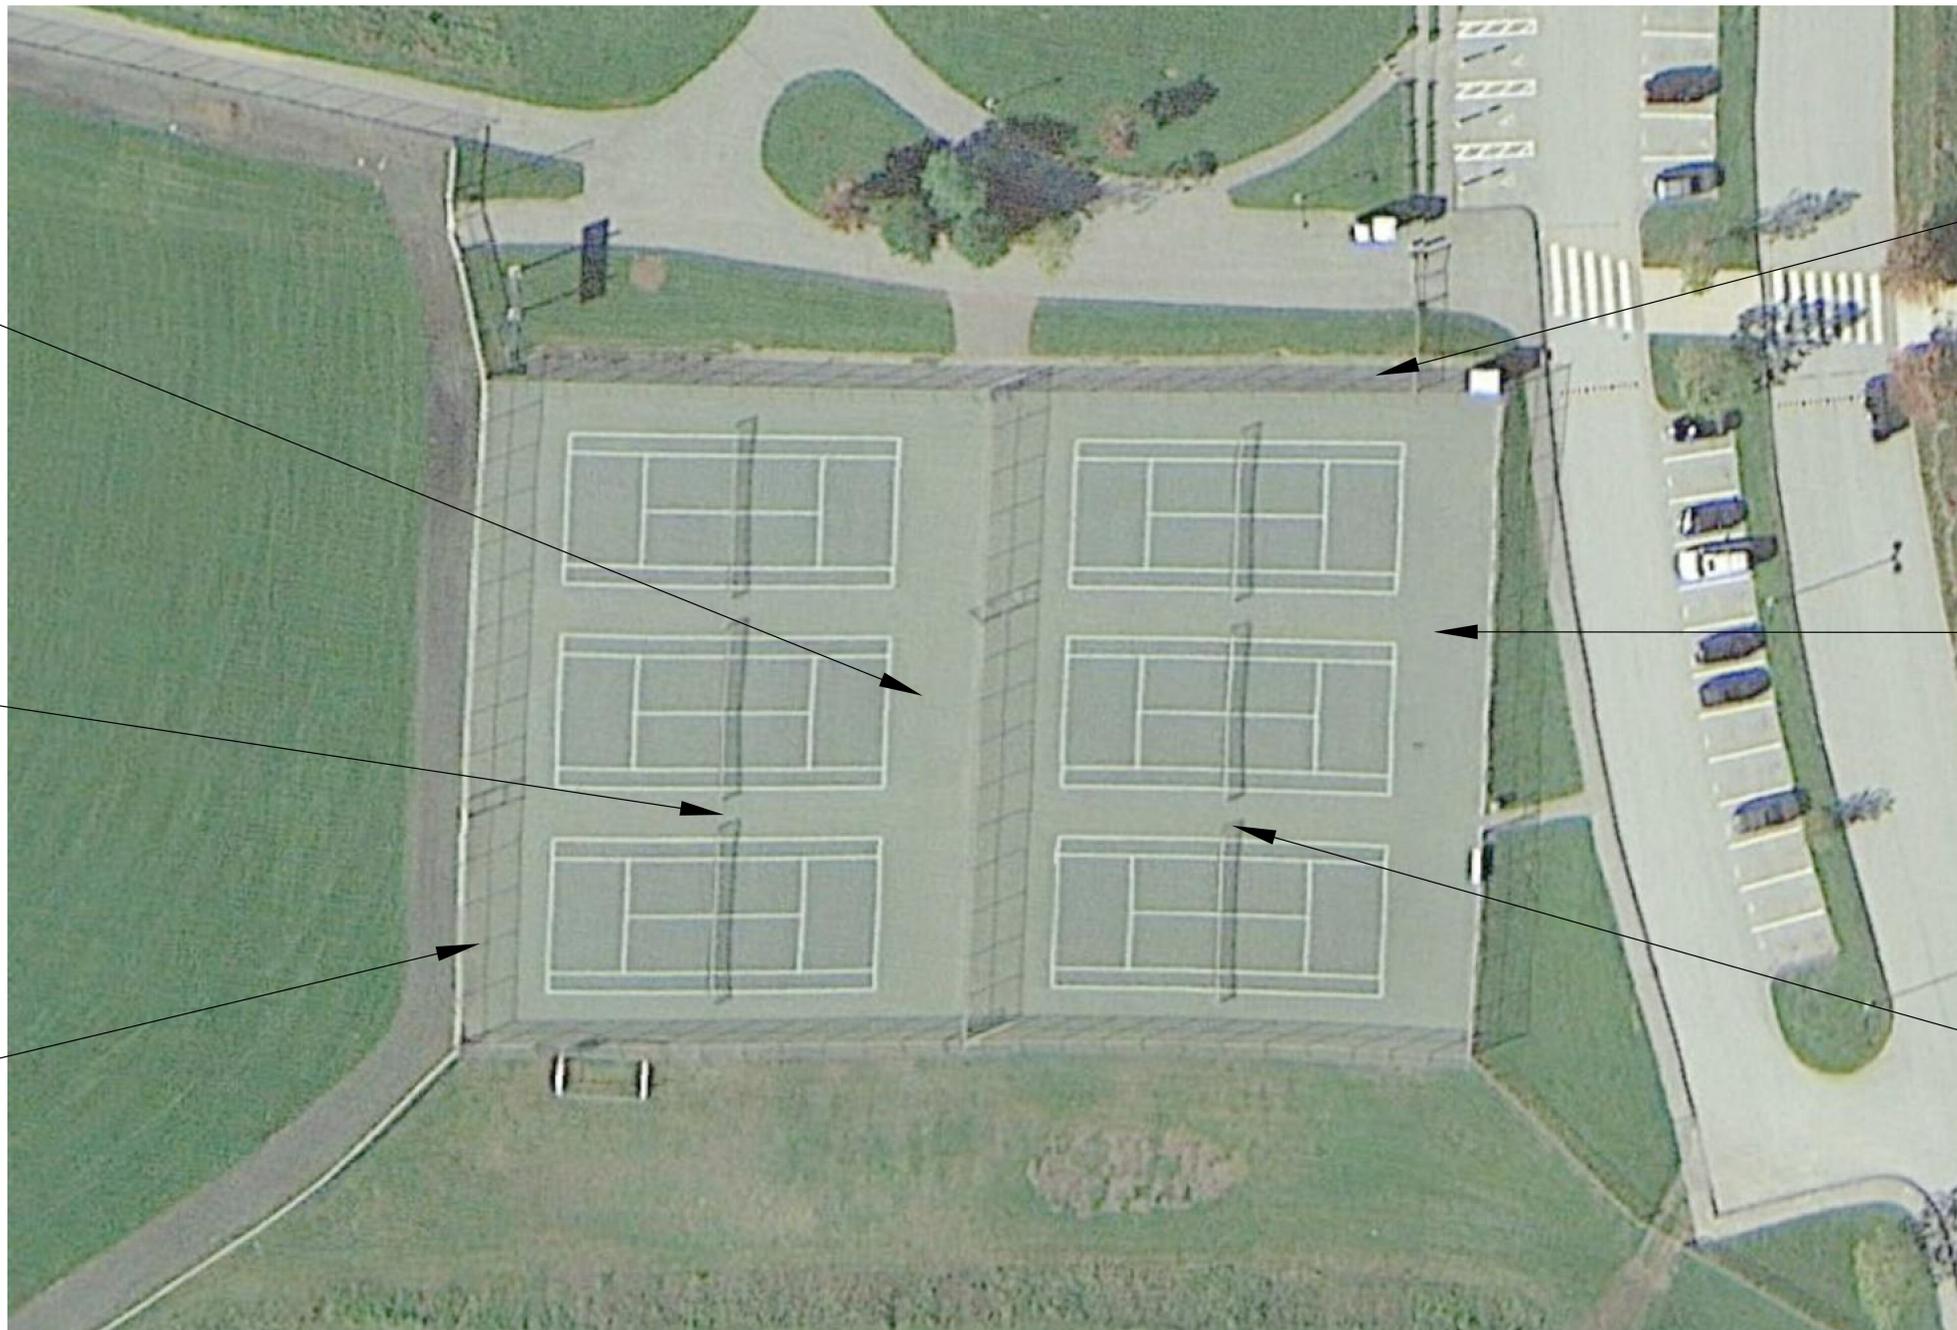
- BITUMINOUS WALKWAY IS NOT CODE-COMPLIANT.
