# Exterior Facilities Study Report

Regional School District 8

RHAM High School and RHAM Middle School

December 30, 2015

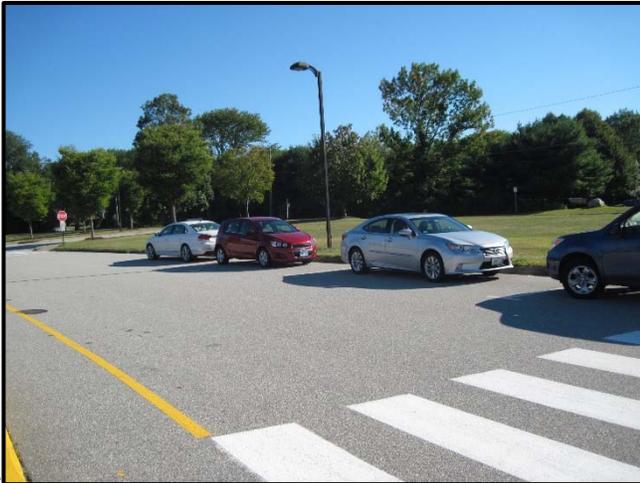
Photo 7 – High School Drop Off Loop cars Parked in Opposite Direction

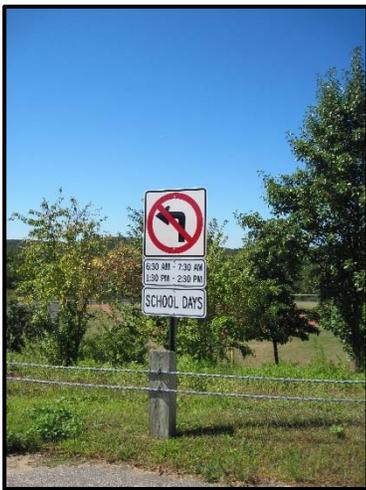
Photo 9 – Excessive Sign Information

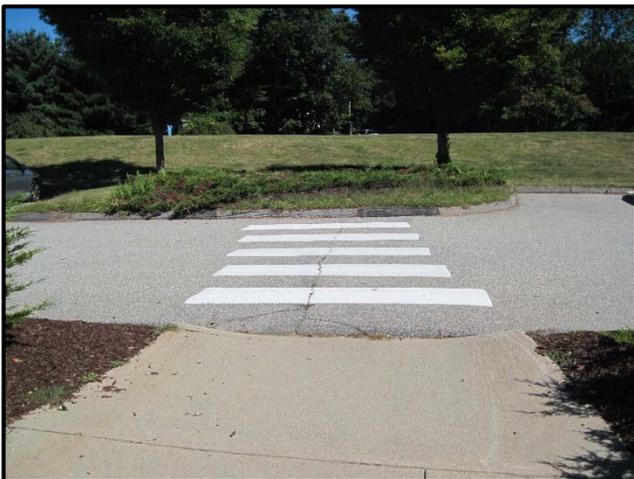
Photo 11 – Crosswalk leads to Planting Bed

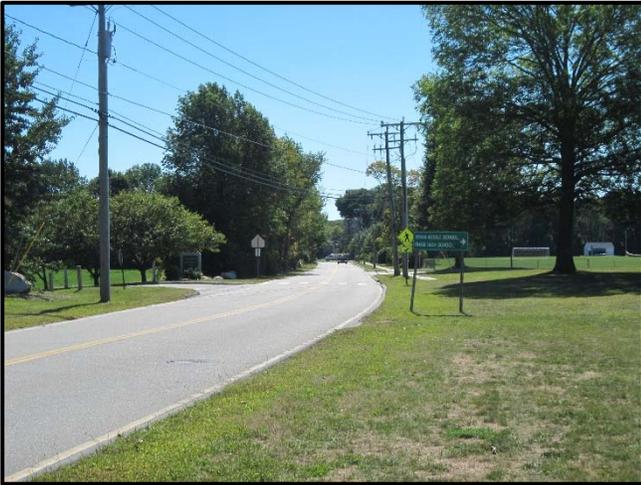
Photos 12 and 13 – Signs on Wall Street Direct Traffic to School Secondary Entrance

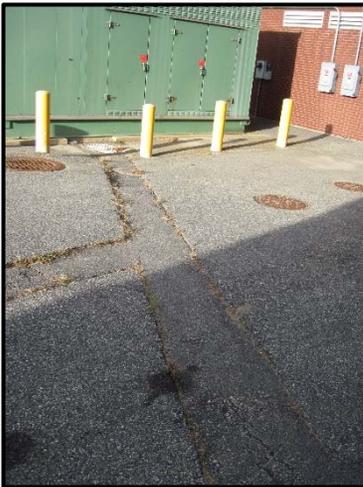
Photo 3 - Example of Patching

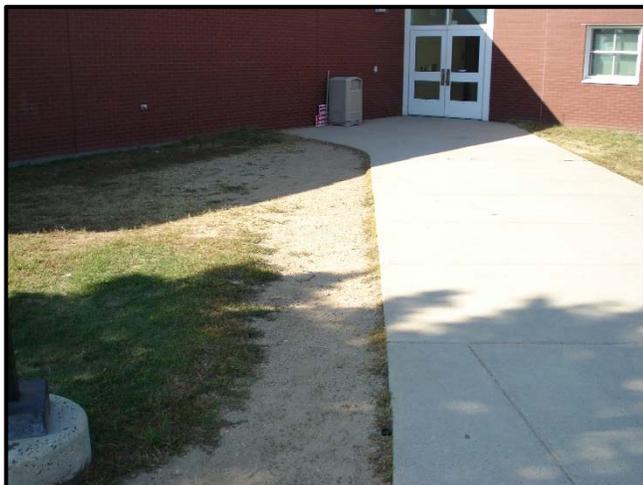
Photo 5 – Gym Entrance – Poor lawn area

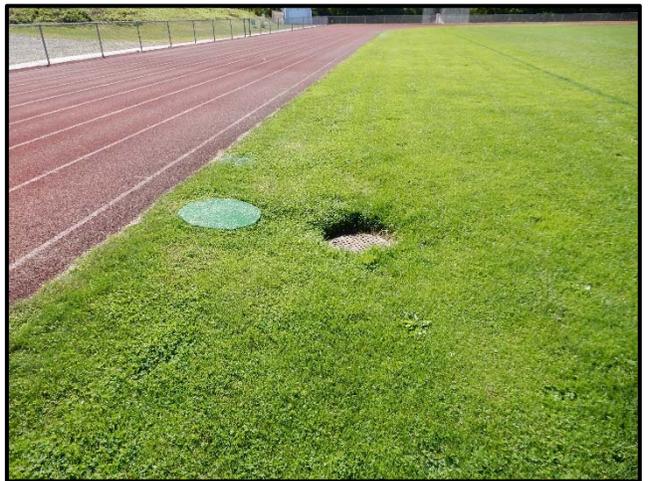
Photo 6 – Typical area drain in field

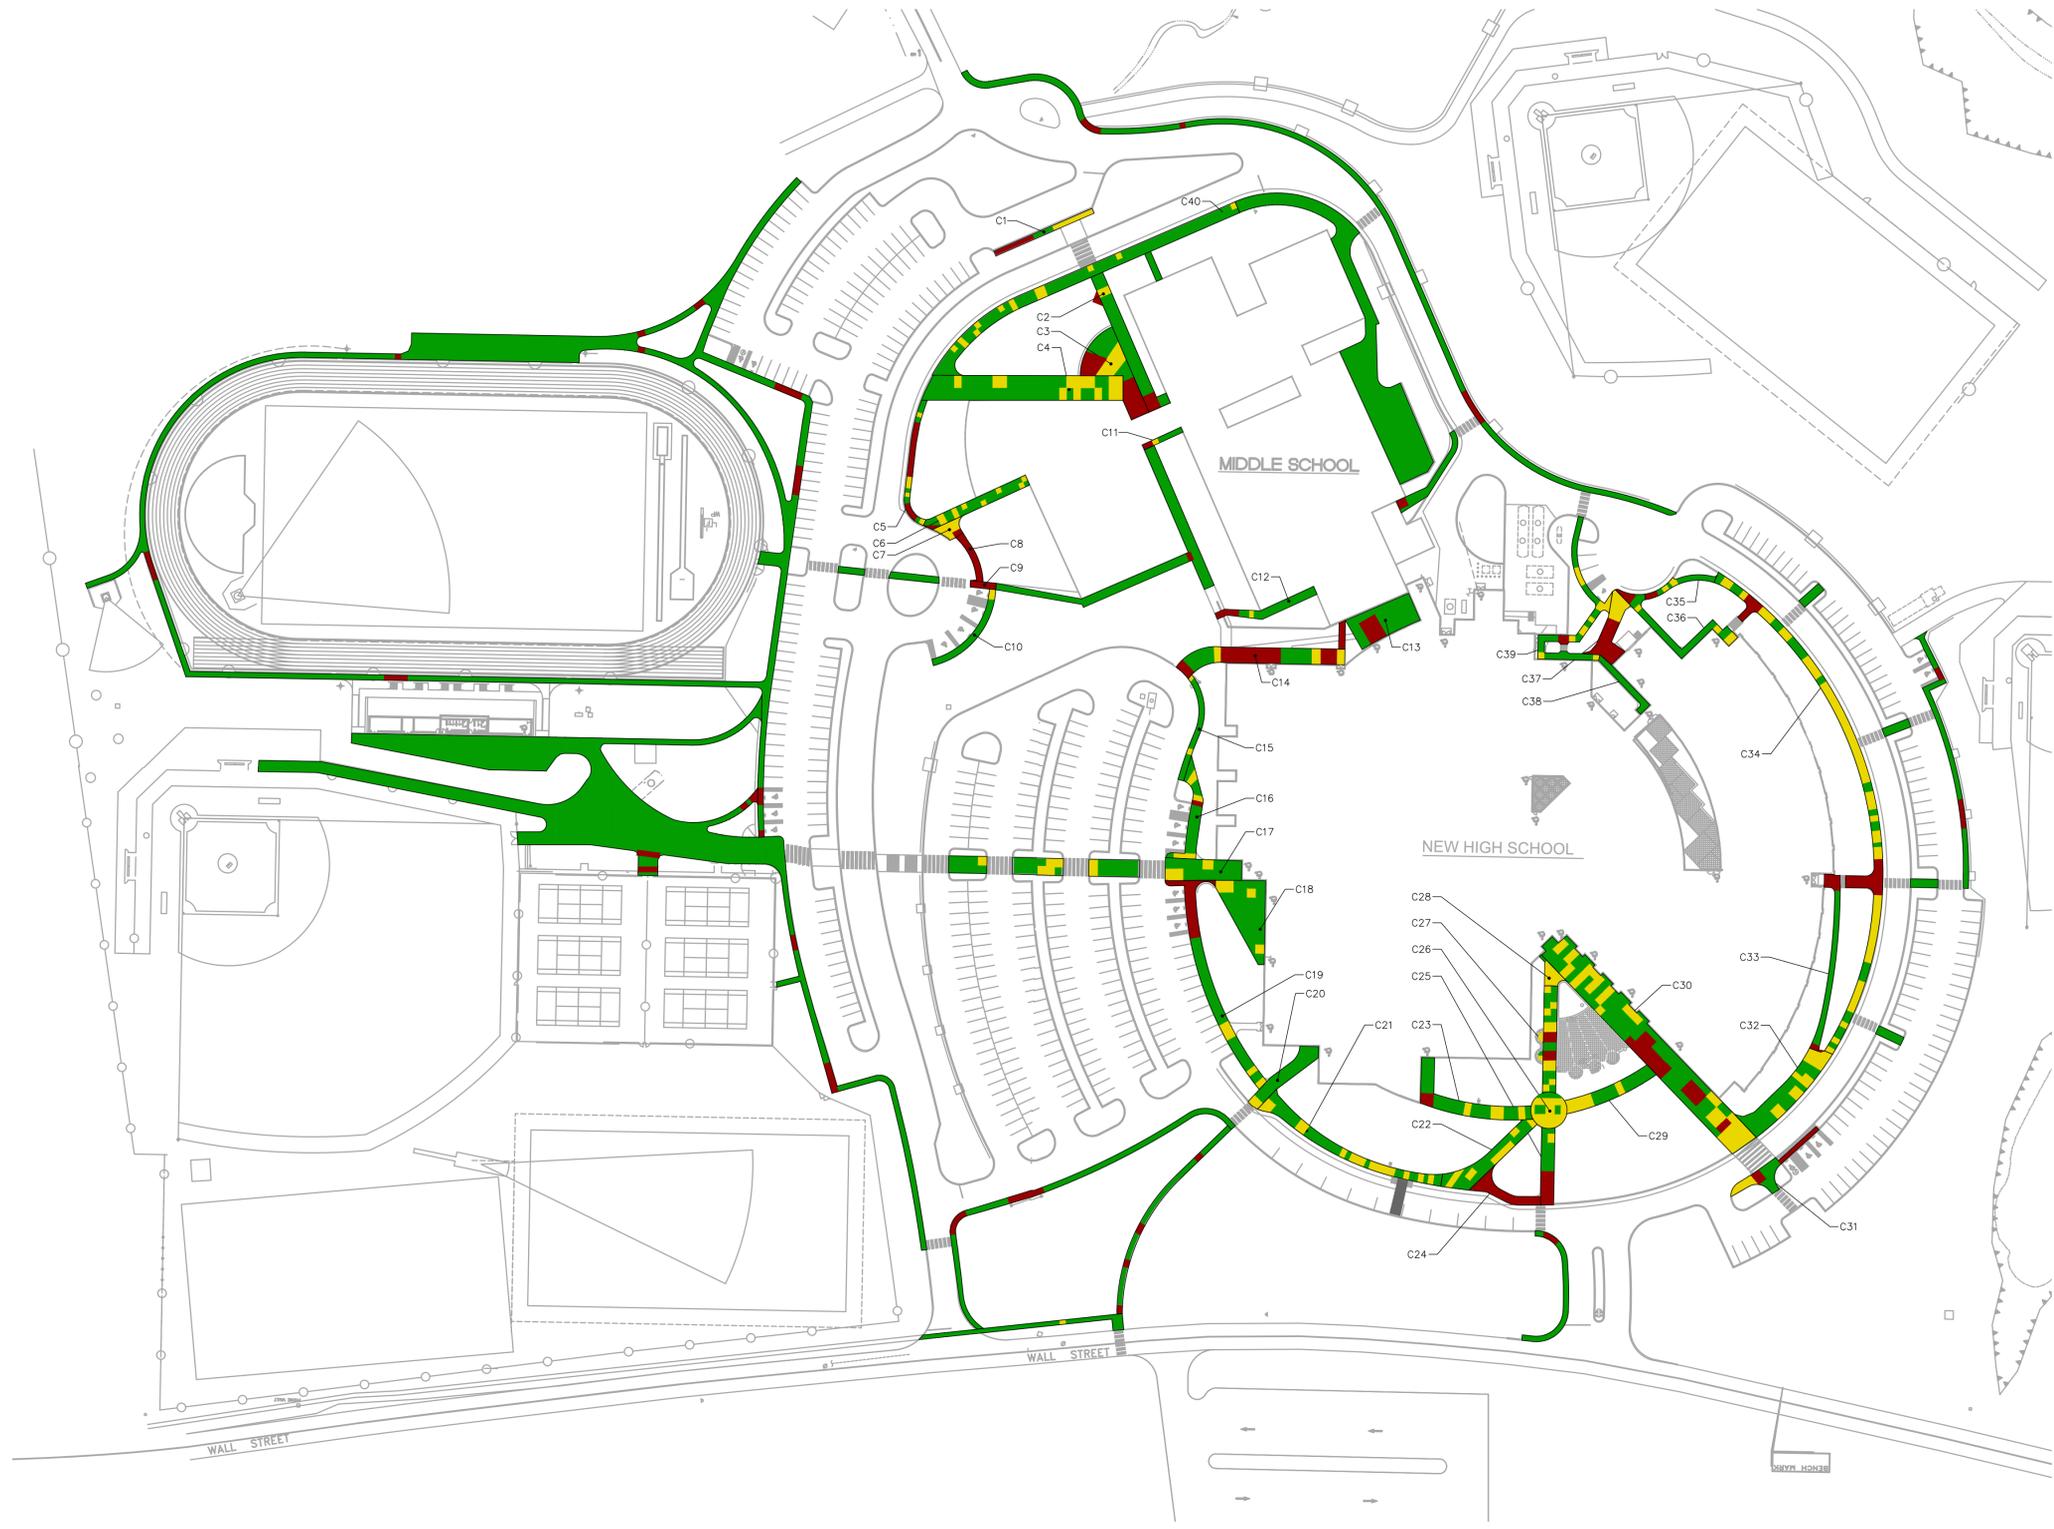
Figure 6 - Sidewalk Condition Analysis  
 RHAM High School Exterior Site Improvements

A graphical summary of the concrete assessment is presented on Figure 6. The Sidewalk Condition Matrix is included as Table 1. Table 1 represents the “raw data” based on the field observations. A Sidewalk Mitigation Matrix is included as Table 2. Table 2 presents the recommended mitigation after analyzing the raw data and making adjustments with consideration for adjacent or associated concrete replacement work to account for economies of scale and avoidance of a “patchwork” scenario where a mixture of replacement and repair may not be desirable. For example, if a “Repair” panel is located within a grouping of “Replace” panels, the “Repair” panel should be replaced. Analyzing the data and deriving the corresponding recommendations in this way is an especially important consideration because it is assumed that repaired concrete panels will continue to degrade over time.
